Thetford Fridge terminology

Product lines

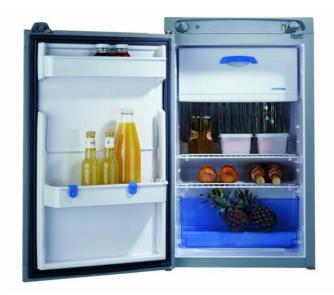
Manual Energy Control (MEC) Piëzo (V85)

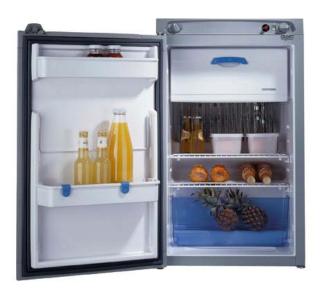
Manual Energy Control (MEC) Piëzo

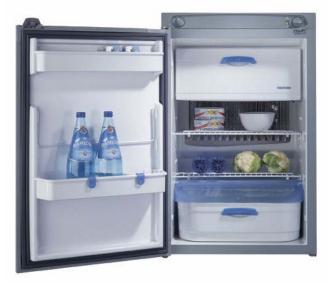
Manual Energy Control (MEC) Electronic

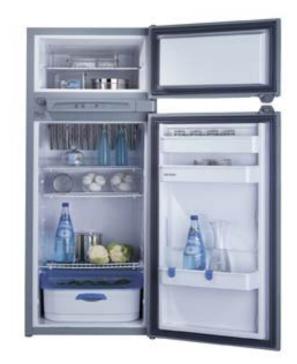
Smart Energy Selection (SES) LED

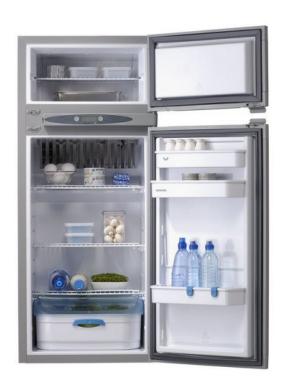
Either Electronic Energy Selection (EES) or Smart Energy Selection (SES) Automatic

Press the left button (mode selection switch), when you see Auto on the left side of the display you have a SES version when not, you have an EES version

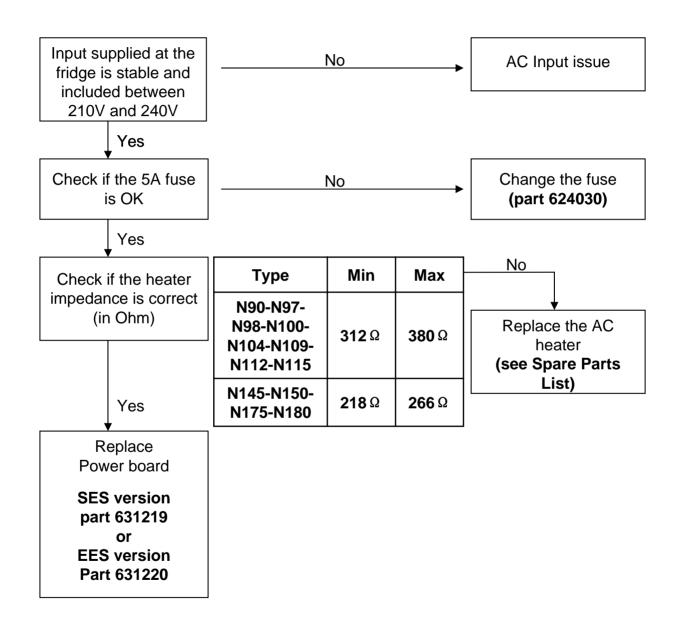
Error code 1 AC heater current is measured to be 75% below nominal current

Part 631220

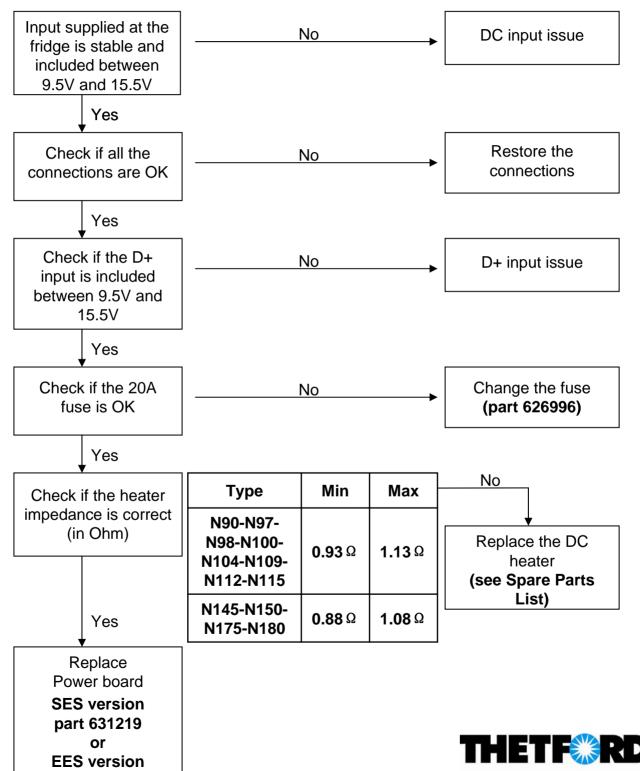
Error code 2 DC heater current is measured to be 75% below nominal current

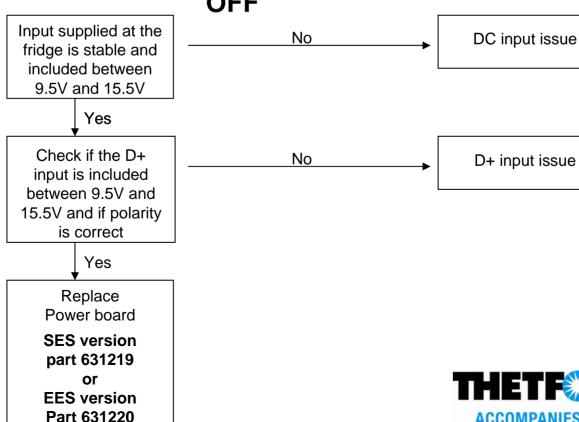
Error code 4 DC heater is ON when it should be **OFF**

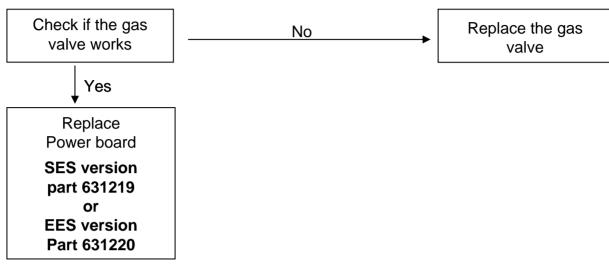
Error code 5 Senses flame when gas should be OFF

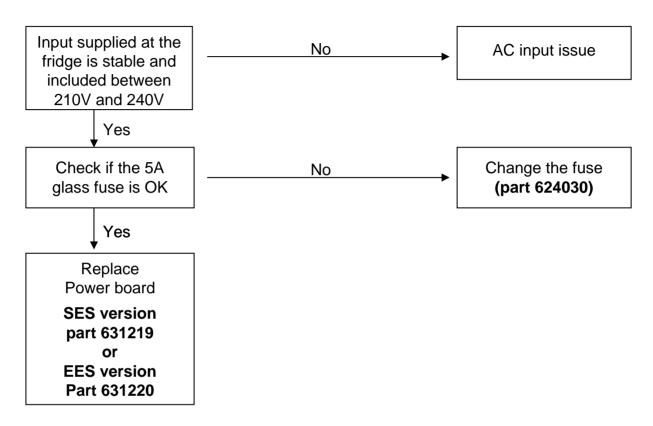
Error code 8 AC mains supply is below 20% nominal

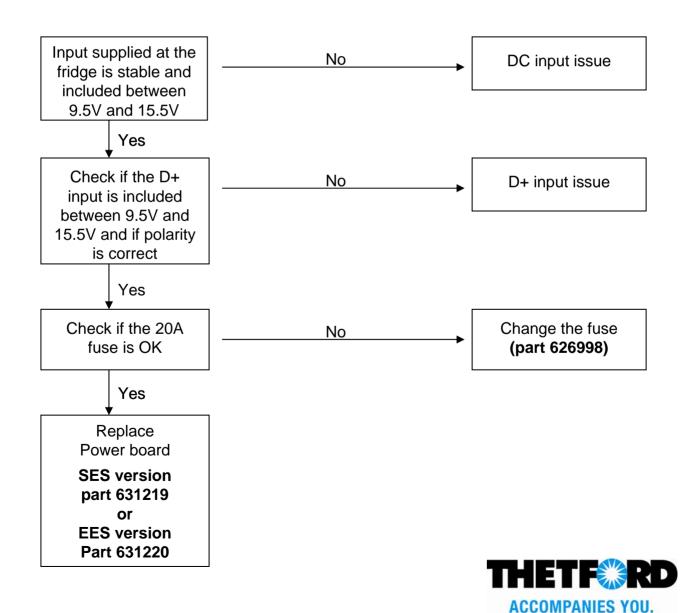
Error code 10 "No engine running" signal is Present and control is in Manual DC mode

To know if D+ polarity is good, select manually DC mode engine off.

If no error code occurs, that means the D+ input is versed.

Ensure power supply is capable to supply correct amperage.

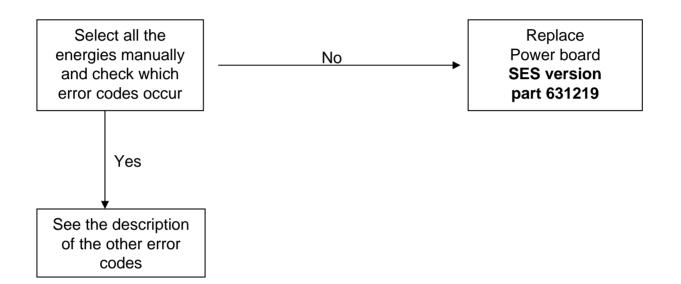
Error code 11 No energy source is available and control is on AUTO mode

Please make sure that all energy sources are available during the trial

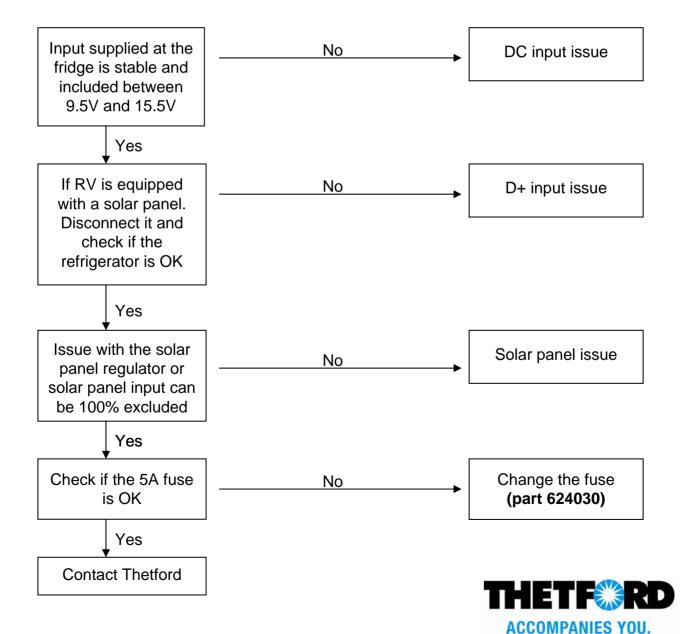
Error code 12 Supply voltage DC is out of range (9.5V – 15.5V)

If DC mode have been selected manually, the refrigerator is not switching automatically on another source of energy when the engine is off

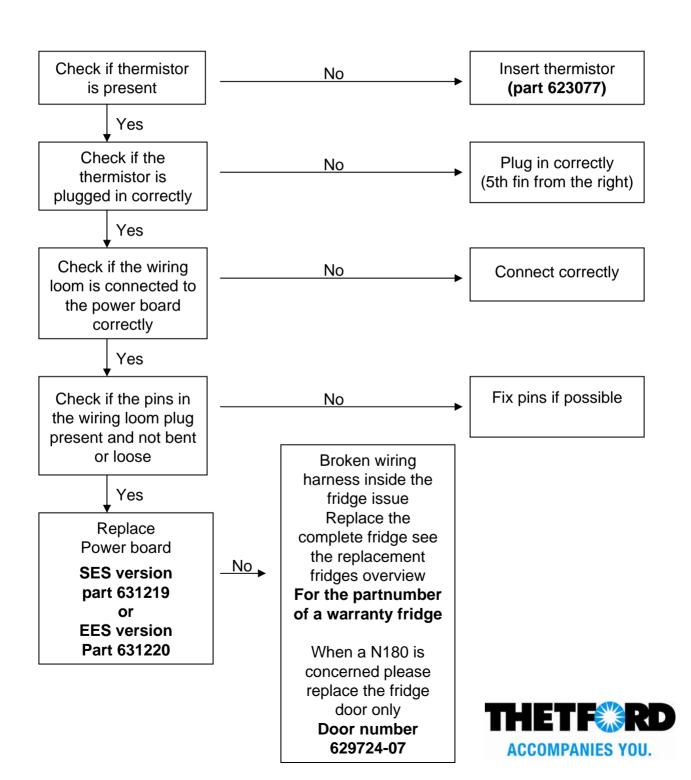
Error code 13 Thermistor fails, control automatically switches to backup mode (BOS)

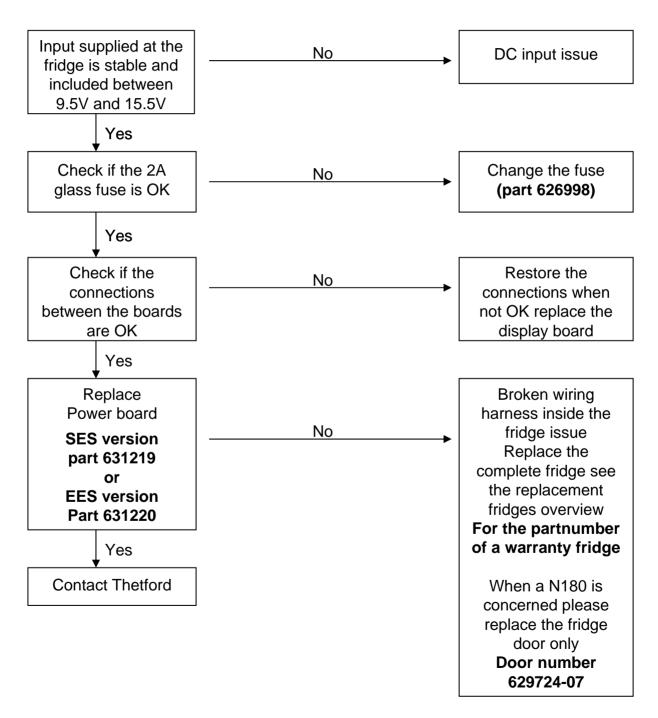
Error code 14 Display board and power board lost communication to each other

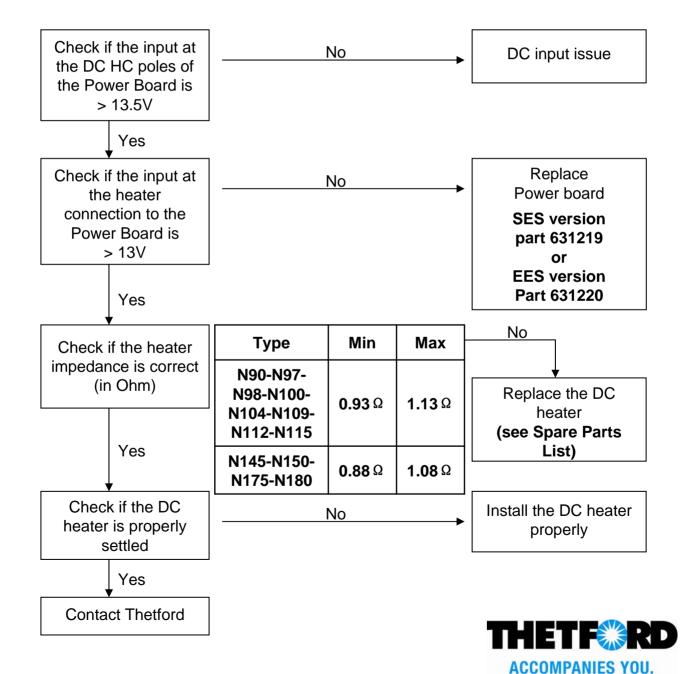
On 12 Volts

Do the testing of the fridges on the manual mode

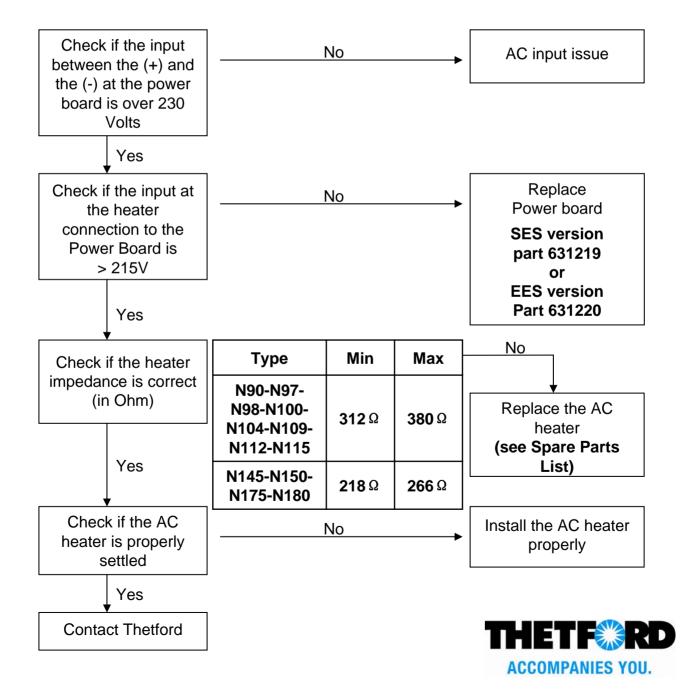
On 230 Volts

Do the testing of the fridges on the manual mode

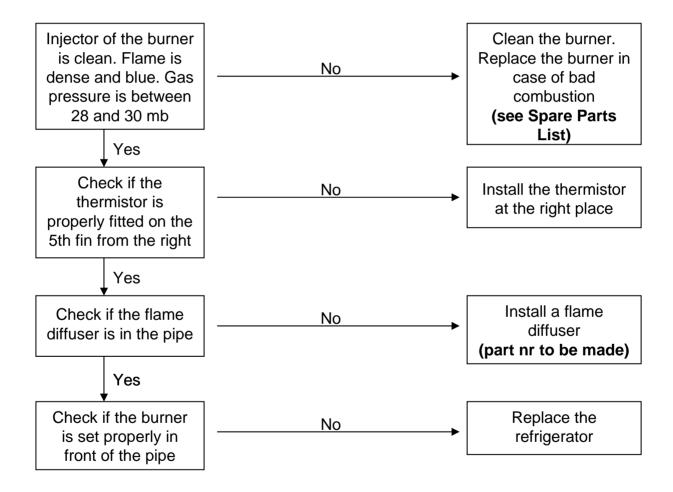
On Gas

Do the testing of the fridges on the manual mode
